TDI

CHECKPOINTS WHEN NO LED LIT ON PWB1

AMS10-8/12/16, F2040-8/12/16

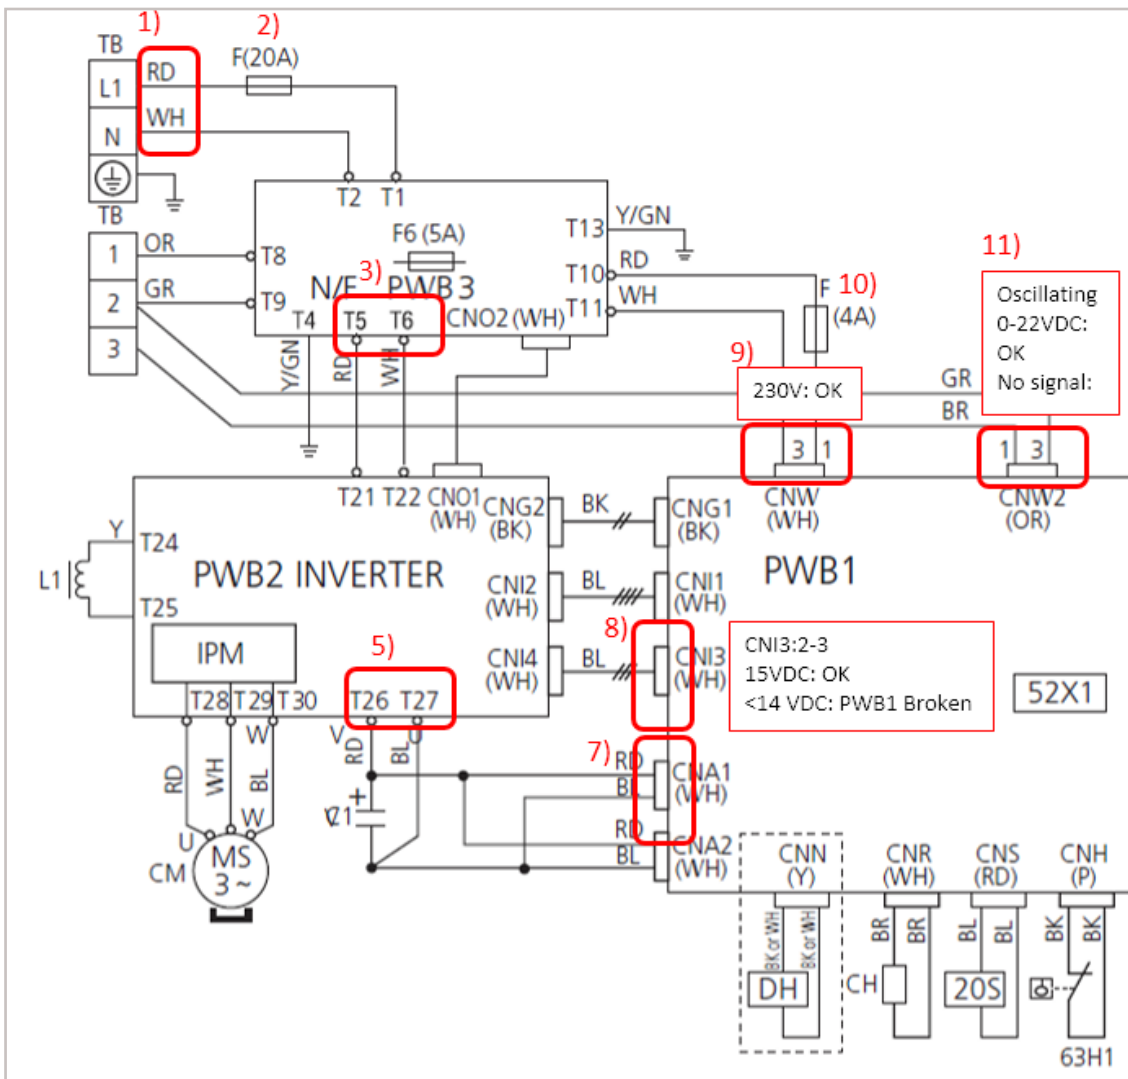
AMS10-8, F2040-8

If all LED on PWB1 is off, check the following points:

1. Incoming power supply (230 V)
2. Is the fuse OK?
12/16 kW; 30A, 10x37mm. 8kW; 20A, 6x30 mm
3. Voltage out from Filtercard PWB3 (230 V), check fuse on the card.
12/16 kW; 8A, 5x20mm. 8kW; 5A, 5x20mm

4. Check voltage between DM and Invertercard PWB2 (310-320 VDC). If no voltage, replace the DM.
5. Check voltage at P2-N2 (12/16 kW), T26-T27 (8 kW) on Invertercard PWB2 (310-320 VDC).

- a) If no voltage, disconnect the compressor and check again.
 - b) If needed replace the Invertercard.
 - c) Check resistance in compressor coils and isolation to ground.

6. Check voltage at P-N2 from AF module to capacitor (310-320 VDC).
 - a) Measure voltage on the capacitor and switch off the power, voltage should decrease slow and steady (2-3 volt per second) down to approximately 60 volt where it drops down to 30 volt. If the voltage disappears directly something is wrong.

- b) Disconnect wires from CNA1 and CNA2 on PWB1 and try again.
 - c) If the same problem remains then probably the capacitor is broken or it could be the PWB1 that is causing it.

7. Check voltage at CNA1 (310-320 VDC)
 - a) If no voltage, disconnect the wiring CNA1 and CNA2 that goes into the card and check again.
 - b) Is voltage still missing? Change Invertercard.
 - c) Do you get the correct voltage when wiring is disconnected? Then it could be a component connected to PWB1 that is creating an overload of the card. Disconnect all wiring except supply and internal communication from PWB1 (CNA1, CNA2, CNI1, CNI3, CNW and CNW2 shall remain connected on AMS10-12/16). Reconnect the other wiring one by one and observe if the voltage disappear. When the voltage disappear you have located the faulty component.
